## SC7640 vacuum checks and pirani settings.

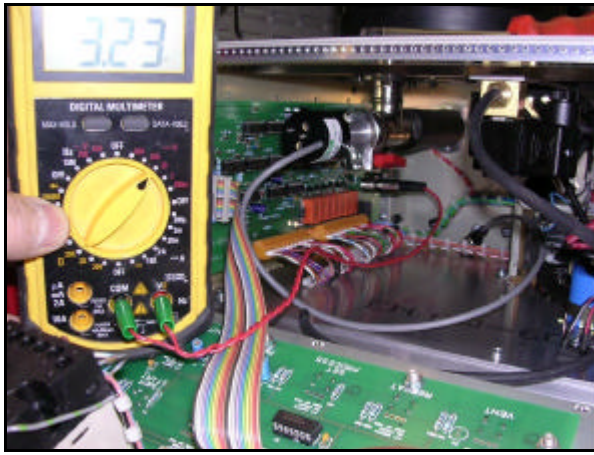
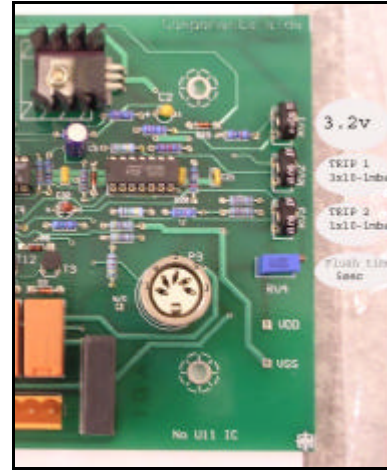
The calibration of the Pirani gauge is set against a reference voltage of 3.2v between pins 2 and 4 on the 5-pin DIN connector of the Pirani gauge. As the power needs to be on the safest way to measure this is to make up a test lead.

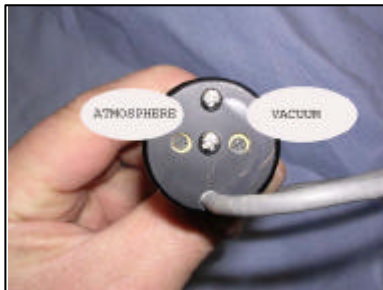
Adjustment for 3.2v is done by the adjustment pot RV1, which is the top pot at the back end of the main board. Take great care and use a suitable extended adjusting tool. Do not adjust any other pots at this stage.

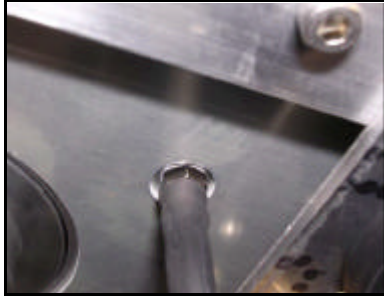
3/. Make sure that the tube fitting into the base plate of the coater chamber is not leaking. It should be re-fitted with thread sealing compound if in doubt.

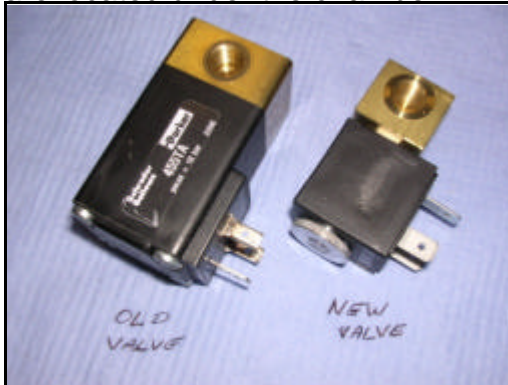
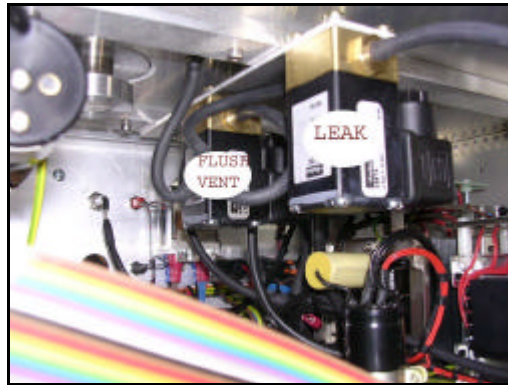
4/. If the chamber pressure is still high enough to generate plasma in the chamber, you should inspect the 'leak' and 'vent/flush' solenoid valves, which are located under the chamber.

If either one of the valves are leaking this will continue to let gas into the chamber. Closing the gas inlet at the back of the chamber and running the coater through its pump down cycle will give an indication of this fault as the inlet pressure will be low and the leak rate reduced. In this condition there may be no plasma but venting the gas inlet may give an increase in the plasma again.

Two kinds of valves were fitted on the SC7640; both types of valve will be susceptible to trapping debris in the valve seal through venting to dusty gas. Take the valve apart and clear any 'dirt' from the seal.
